DELIVERABLE D.T. 5.1.2

# Joint questionnaire on flood impact data

EMfloodResilience

INTERREG Euregio Maas-Rijn | Project No. EMR228

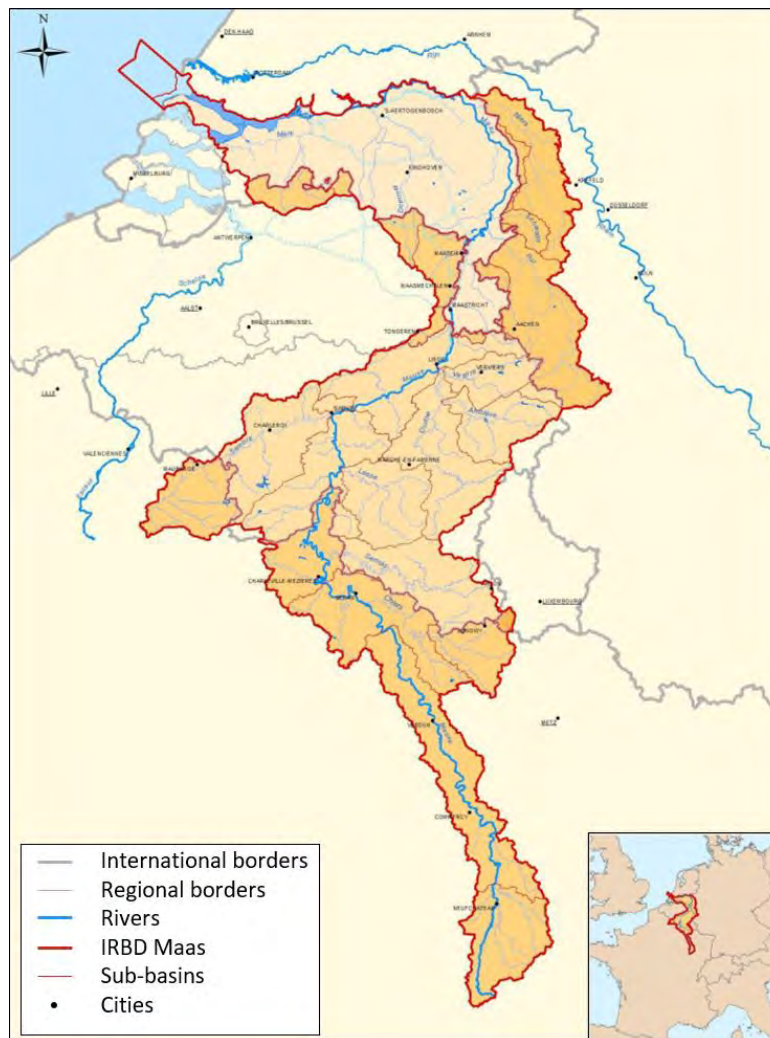
Figure 1: International River basin district Meuse, changes according to Bezirksregierung Köln (2021).

The study areas in all three contributing countries are located within the international river basin district of Meuse, which is shown in Figure 1. The area of the international river basin district is 34,347 km<sup>2</sup> (IMC 2022) with parts in France, Belgium, the Netherlands, Luxembourg and Germany (Bezirksregierung Köln 2021) and holds about 8.8 million people (IMC 2022). The Meuse originates in France, flows through Belgium and enters the North Sea in the Netherlands (Bezirksregierung Köln 2021) after 905 km (IMC 2022). The upstream part of the Meuse basin is characterised by agriculture and forestry activity, whereas the downstream part is characterised by intense economic activities and a higher population density (IMC 2022) All flooded rivers in the study area are tributaries of the Meuse.

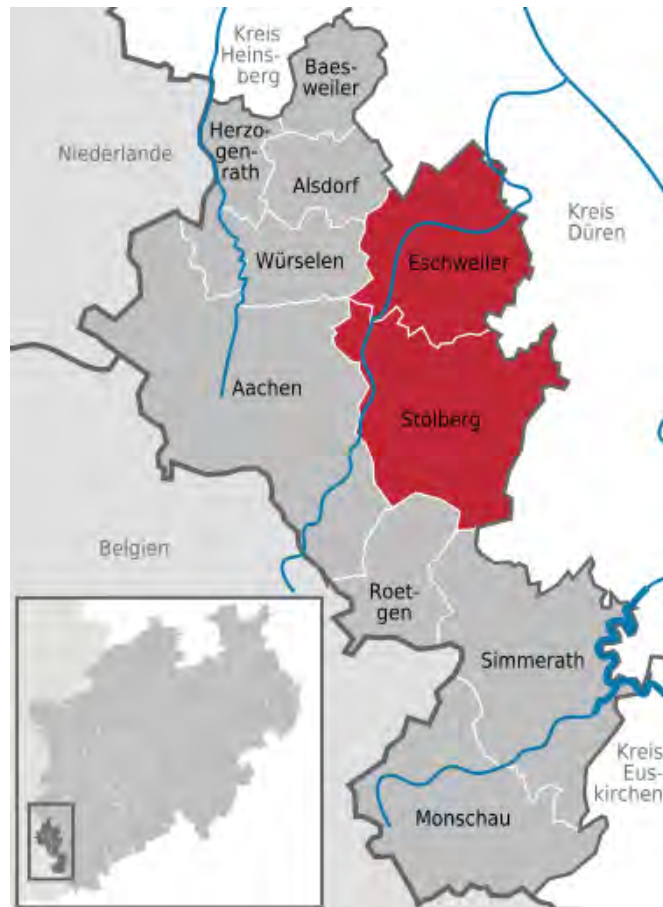
Figure 4: Municipalities of Stolberg and Eschweiler

The areas that experienced the most significant impact from the 2021 flood in Germany were the Ahr Valley in Rhineland-Palatinate and some regions in North Rhine-Westphalia, including the cities and corresponding villages of Stolberg and Eschweiler, which was selected as a survey area for the purpose of this project. Both cities are part of the Aachen district, as indicated in Figure 4.

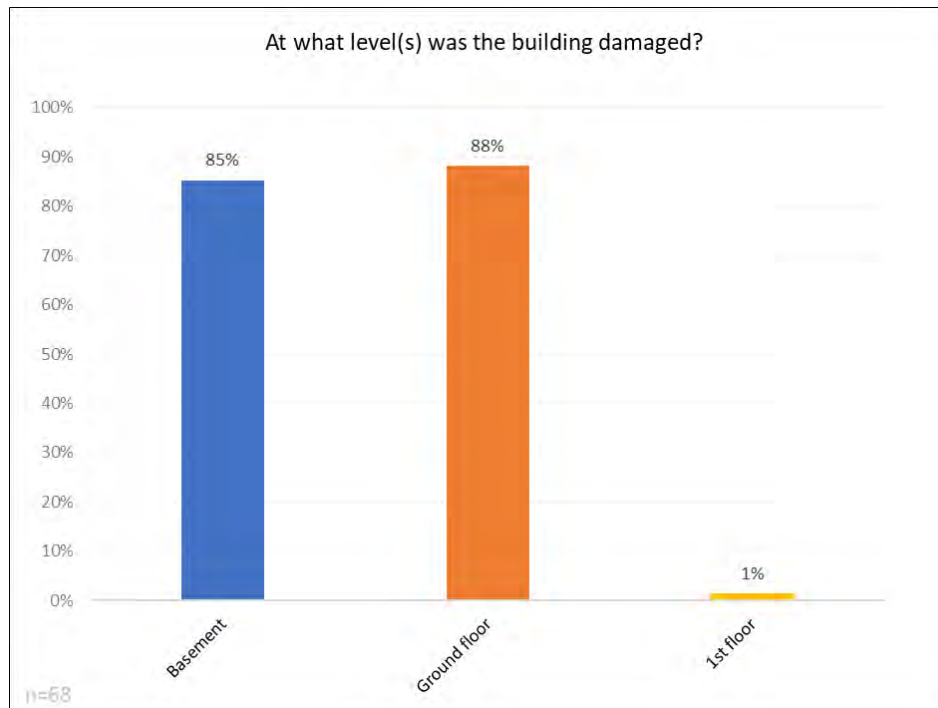
Figure 19: Percentages of the levels, on which the homes of the participants are damaged, Belgium (questionnaire part 2 residential, question 9).

In the Belgian studied area, in general, both the basement and the ground floor experienced flooding (Figure 19), with a median water depth of 1.7 m. The highest recorded water level outside the building reached 2.75m in the surveyed area (Figure 20). The flood event was characterized as a fluvial flood. This is in agreement with the perception by the population that the overflow of a watercourse was the main cause of the dwellings being flooded (Figure 21). In addition to high water depths, the flood was described as a fast flow, as indicated in Figure 22 and Figure 23, where 64% people defined the flood as torrential.

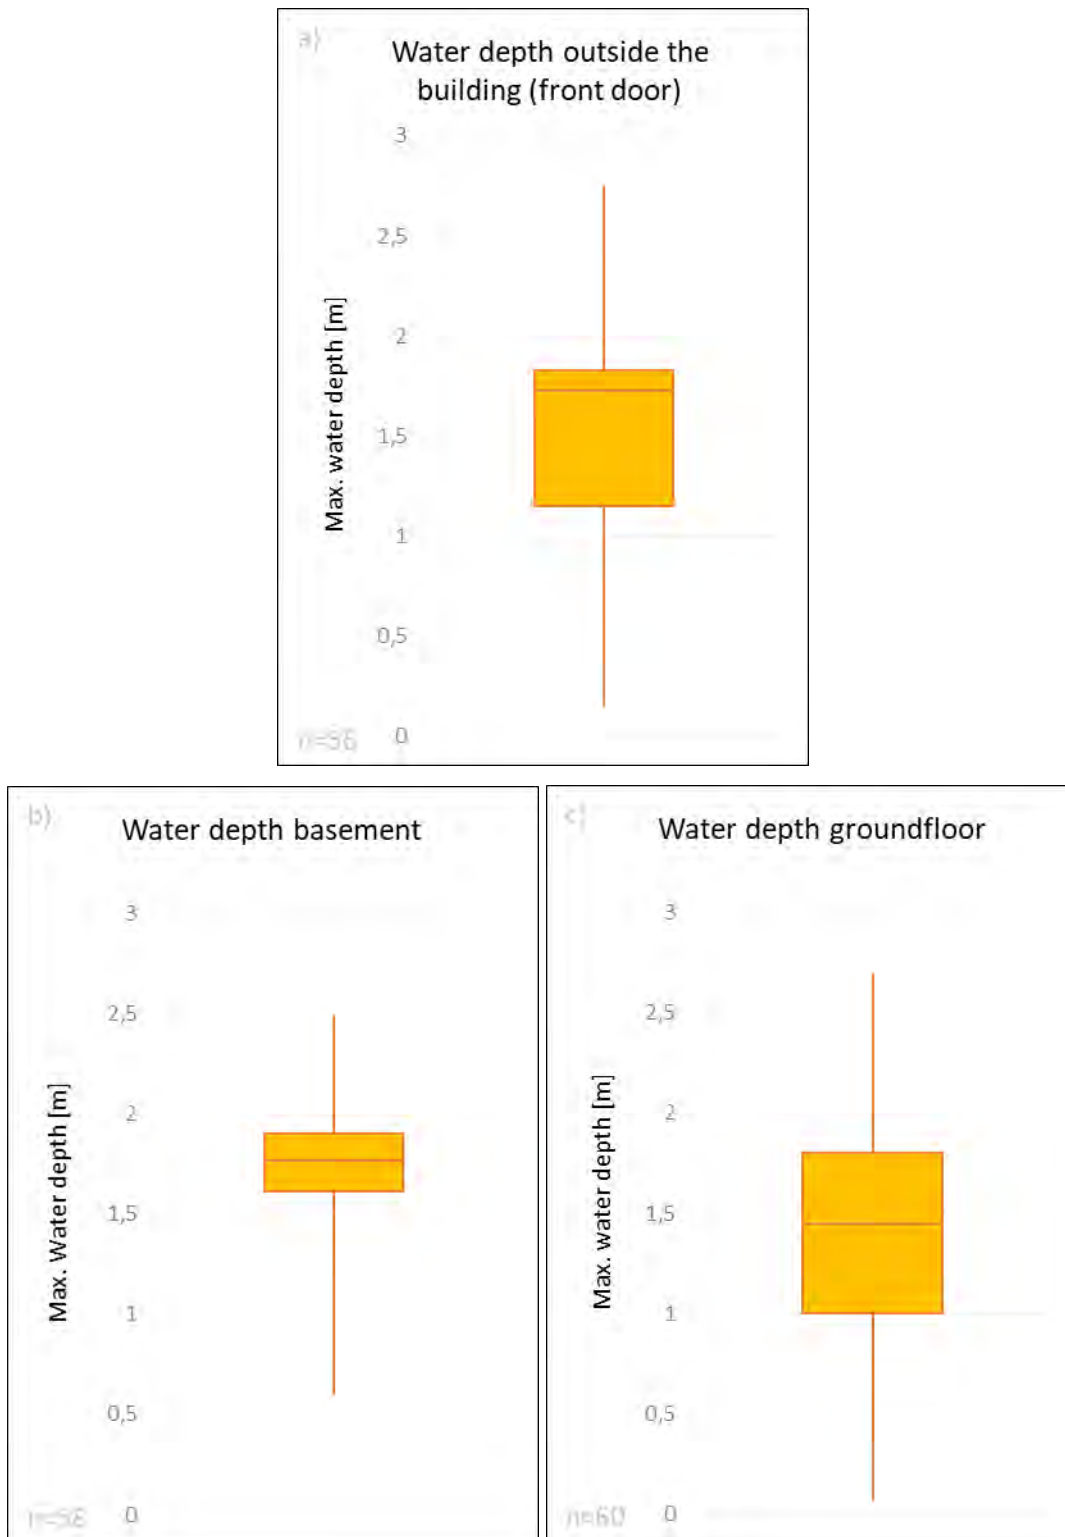
Figure 20: Box plot of the maximum water depth during the flood a) outside the building (front door), b) in the basement and c) on the ground floor, Belgium (questionnaire part 2 residential, question 3).

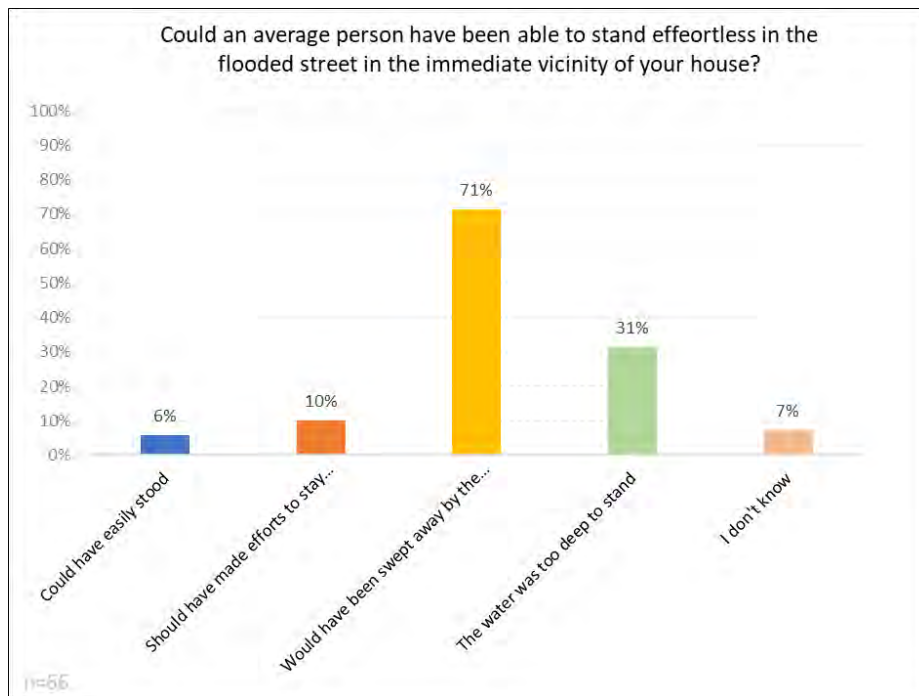
Figure 22: Percentages of subjective estimates of the magnitude of the momentum/velocity by the participants, Belgium (questionnaire part 2 residential, question 7).

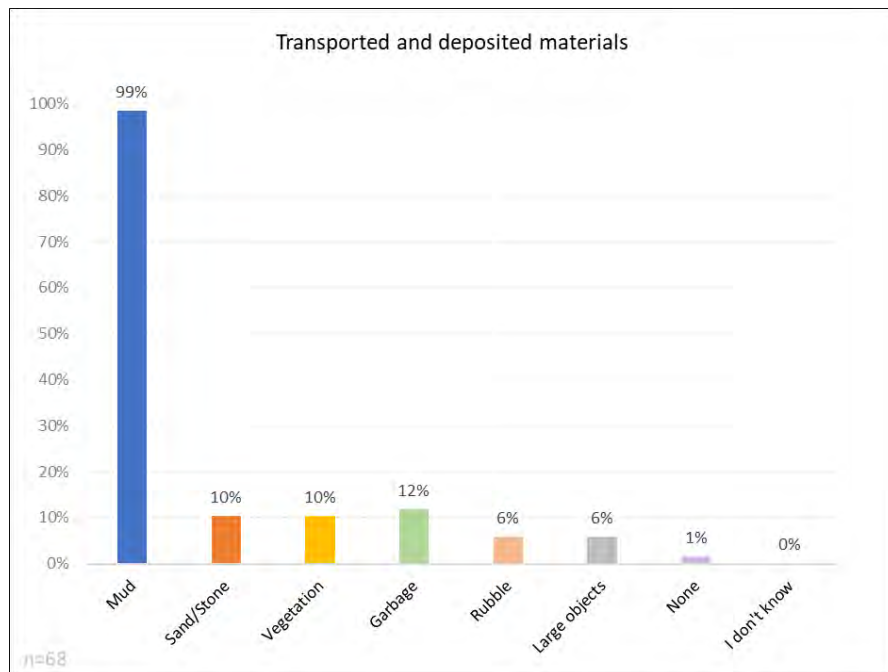
Figure 25: Percentages of what materials were transported or deposited in the buildings or had direct contact with them, Belgium (questionnaire part 2 residential, question 11).

In addition to the velocity, which allowed the transportation of large debris (between 2 and 3 m in length, as shown in Figure 24), the flood was also characterized for containing sediments and contaminants. Almost all the respondents reported to have encountered transported or deposited material from the floodwaters. Mud, sand, stones, vegetation, garbage, rubble, and large objects with a maximum size of 3 m, were the reported materials in the water. The presence of mud in 99% of the cases has induced a considerable work to clean and dispose the material out of the houses after the event (Figure 25).

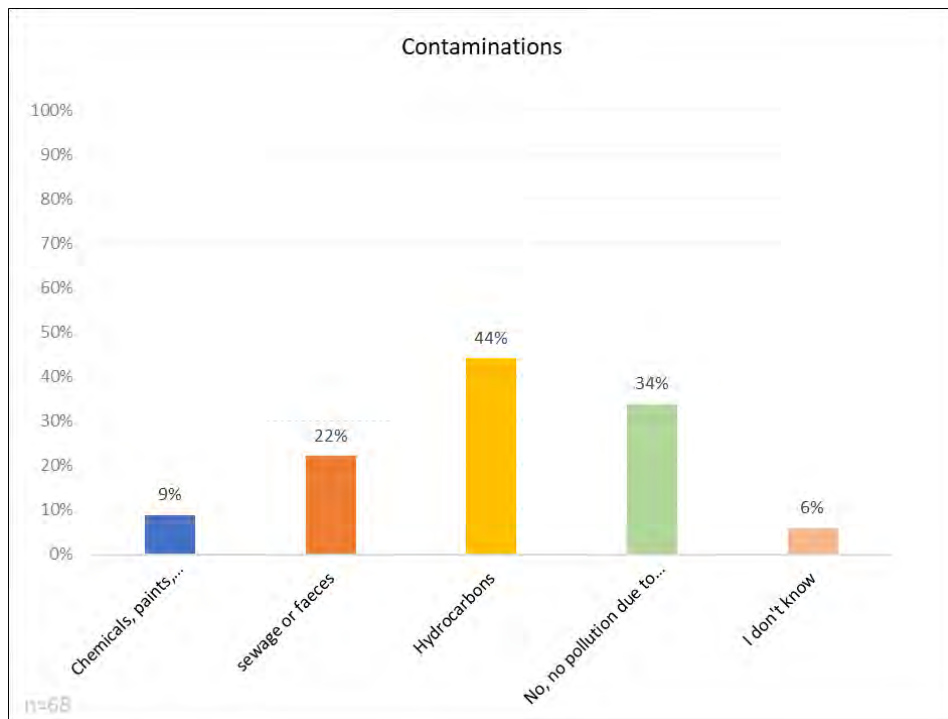
Figure 26: Percentages of the records of the observed contaminants in the homes of the participants, Belgium (questionnaire part 2 residential, question 14).

In addition to the presence of sediments, contaminants such as chemicals, sewage water and hydrocarbons were also reported by the inhabitants. In Belgium, 44% of the buildings experienced presence of hydrocarbons, which add an additional cost of decontaminating the floors and walls in contact with the water (Figure 26).

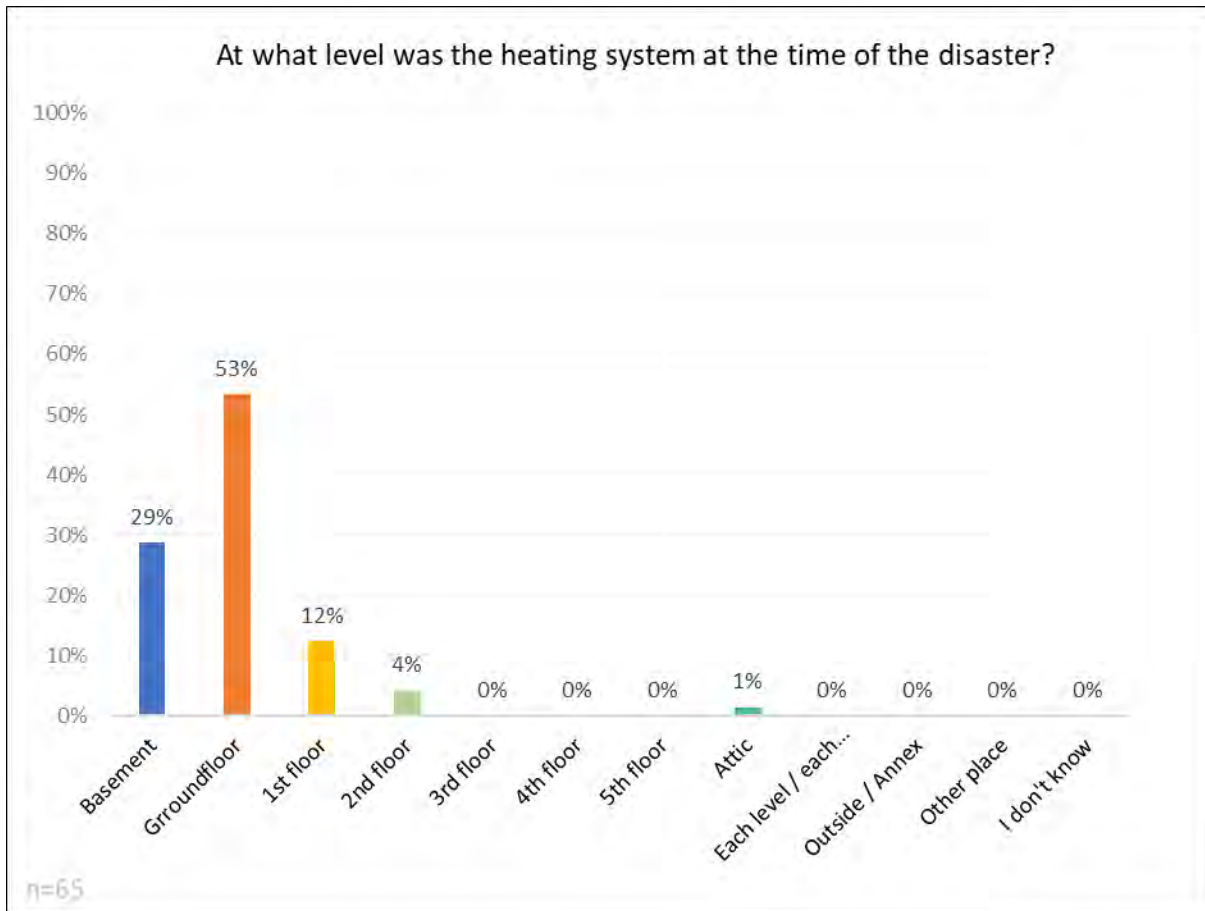
Figure 27: Percentages of at which the heating system was located before the flood, Belgium (questionnaire part 2 residential, question 37).

While conducting field surveys, it became evident that the presence of hydrocarbons within buildings is, in part, attributable to the common practice of housing heating systems in basements (29% as shown in Figure 27). In certain instances (12%, as indicated in Figure 156), these heating systems utilize oil. Adequate protection against floating of the oil tank may have been missing in some cases. Consequently, during a flood event, these systems are prone to oil leaks and spillage.

Given that the basement was typically used as a storage area prior to the flood event, with an occurrence rate of 84% (as depicted in Figure 155), various valuable items such as wine, food, and personal collections were also lost. Additionally, the heating system control was situated in the basement in 29% of cases and on the ground floor in 53% of cases (as indicated in Figure 27).

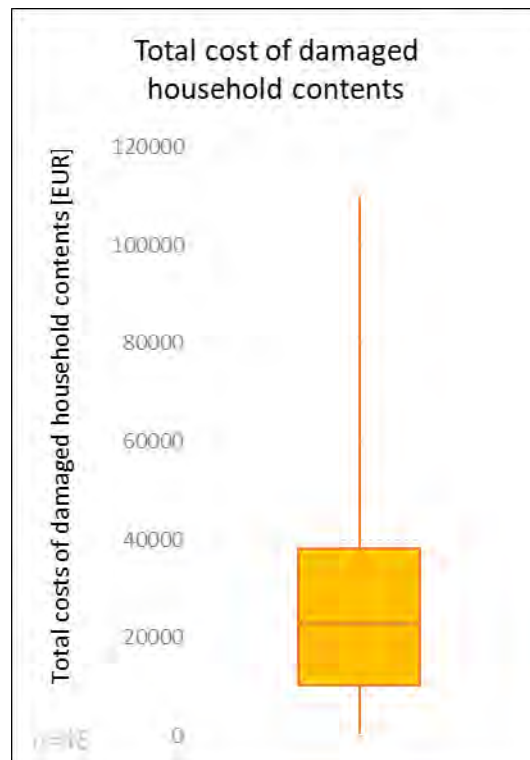
Figure 30: Box plot of the total costs of damaged household contents of the participants, Belgium (questionnaire part 2 residential, question 19).

The field survey has enabled collecting information on the damages to the buildings and their content. Regarding the building content, the affected population lost many types of appliances and household items as shown in Figure 149. Most of them are commonly located on the ground floor, which is generally finished and furnished as shown in Figure 147. Apart from important electrical appliances, the respondents experienced in 90% of the cases loss of memorabilia, which are intangible damages difficult to quantify and, in most cases, impossible to replace (Figure 149). The reported monetary losses for the household items, estimated at 85% by experts, has a median value around 23,000 euros for the surveyed buildings (Figure 30).

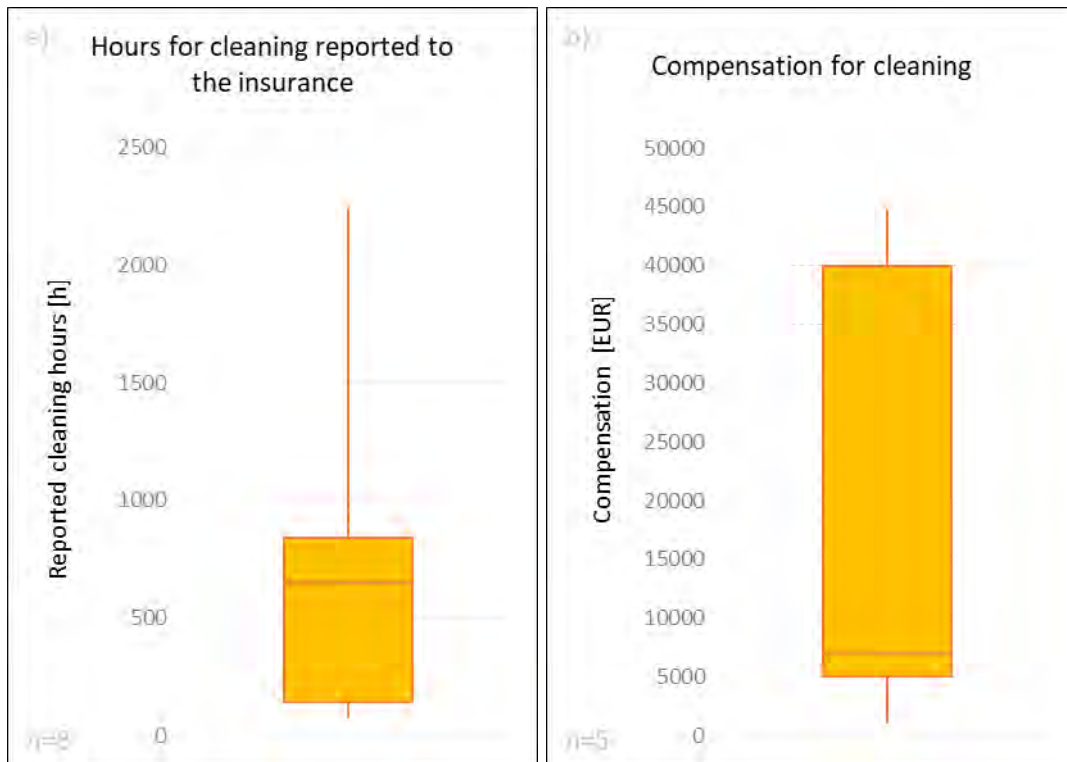
Figure 261: Box plot cleaning the building, a) reported cleaning hours to the insurance, b) compensation for cleaning from insurance, Netherlands (questionnaire part 2 commercial, question 54-55).

An overview of the cleaning hours and costs can be found in Figure 261. Compensation for cleaning was much higher than seen at the residential buildings. The building footprint area could play a role in this, as this was much larger in the commercial sector. Costs for dehumidification and the total costs can be seen in Figure 262.
