DELIVERABLE D.T4.1.1

Data collection, modelling and prediction

EMfloodResilience

INTERREG Euregio Maas-Rijn | Project No. EMR228

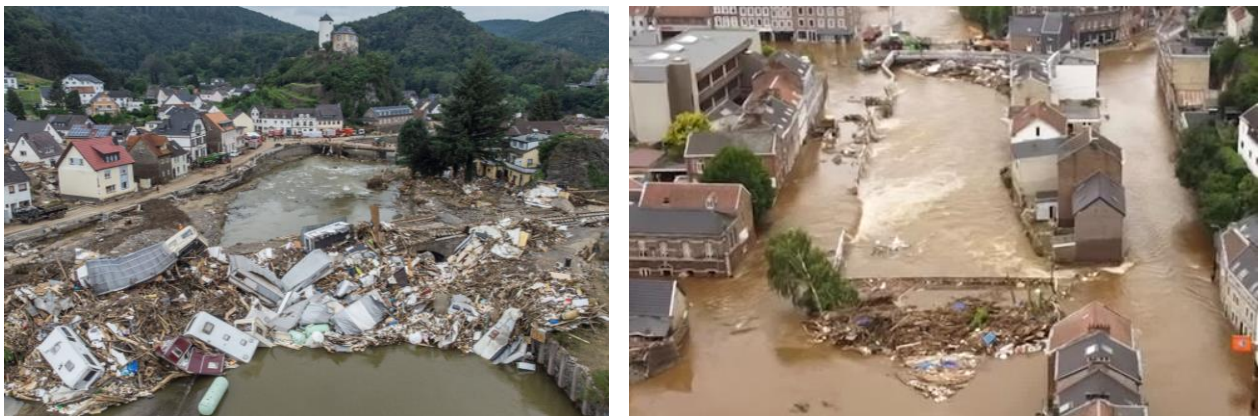
Figure 4: Two extreme examples of debris accumulation, with trees, building rubble, caravans, tanks and other materials show the backwater rise caused by accumulations. Location: Kreuzberg, Germany and Pepinster, Belgium.

With the help of the data collection on debris accumulation, the total volumes as well as the different debris compositions were determined, and characteristic bridge designs established. The observed debris accumulations at the bridges in Belgium and Germany ranged in size from a few m³ to more than 4000 m³, i.e. up to 88 m³ per meter of bridge length. Especially large accumulations were able to disrupt the normal flow of the river and cause substantial backwater rise (Figure 4). Moreover, debris accumulation and flooding caused widespread bridge damage. Of the 71 bridges with debris accumulation, 13 were structurally severely damaged and a further 19 too damaged to be kept in service. In the Netherlands, no significant bridge clogging was identified. Clogging did occur at one submerged culvert, near Bunde. Although the accumulation was relatively limited compared to those in Belgium and Germany, the resulting reduction of the already insufficient culvert discharge capacity means the debris intensified local flooding.

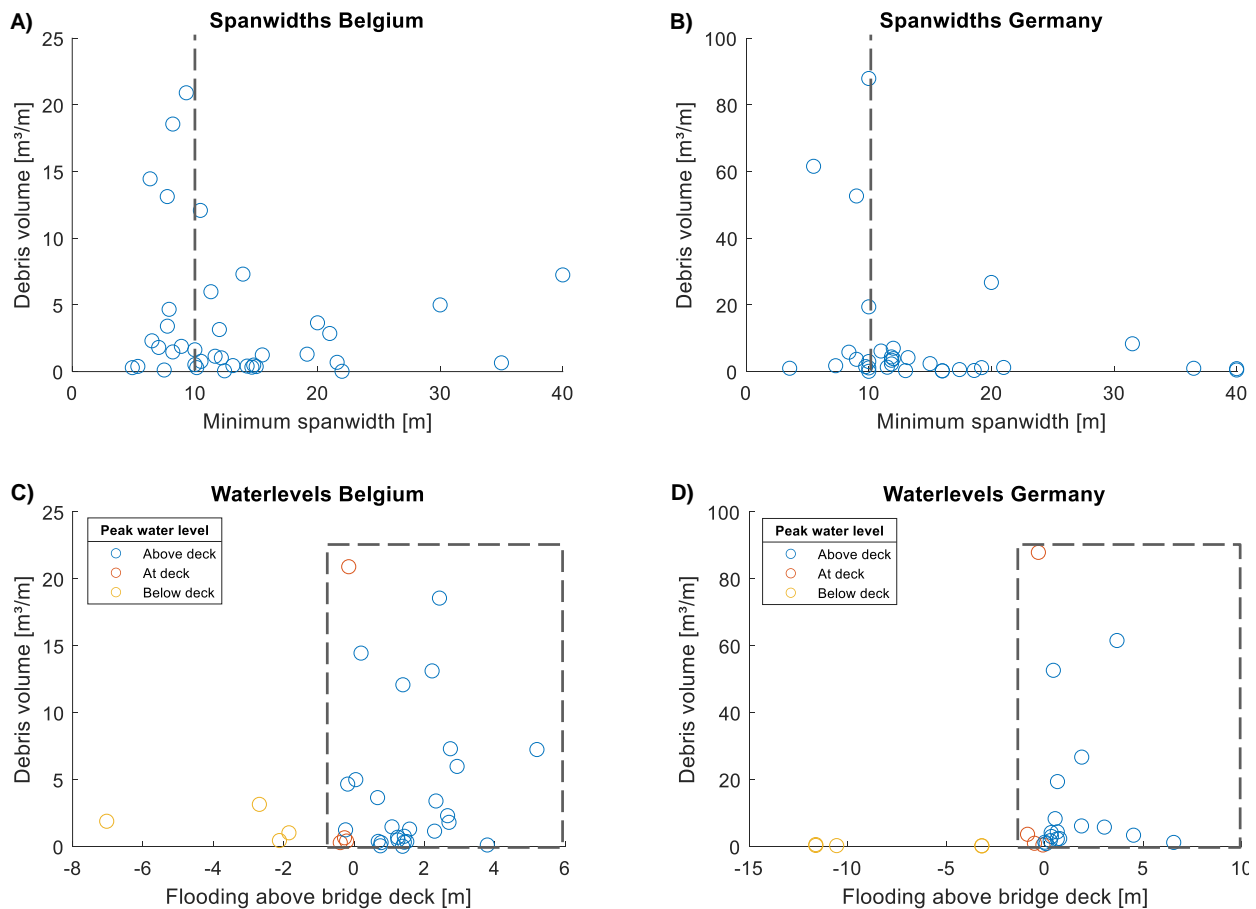
Figure 6: Observed debris volumes, per unit meter width as a factor of span width (pier spacing) and flood height above the river deck. Dashed lines indicate the region where large accumulations are most likely.

Next, the bridge design and geometry at all debris accumulations were studied. In both countries, the largest accumulations occurred at bridges where the distance between piers was small (≤ 10 m), allowing large blocked trees to bridge the distance between piers, thereby initiating clogging (Figure 6A, 6B). Simultaneously, at the majority of the bridges, and at all bridges with large accumulations, peak water levels reached at least the bridge deck, and frequently exceeded it by several meters (Figure 6C, 6D). This has major implications: first, having water reaching the superstructure (deck and railings) means that the deck and railing will already be responsible for backwater rise, irrespective of any debris. Secondly, it means the superstructure interacts with debris, with debris being blocked by the deck and railing, or, if the water level is high enough, flowing over the bridge to continue downstream. Third, this results in additional forces on the bridge superstructure, such as buoyancy forces, which can endanger the stability of the bridge.

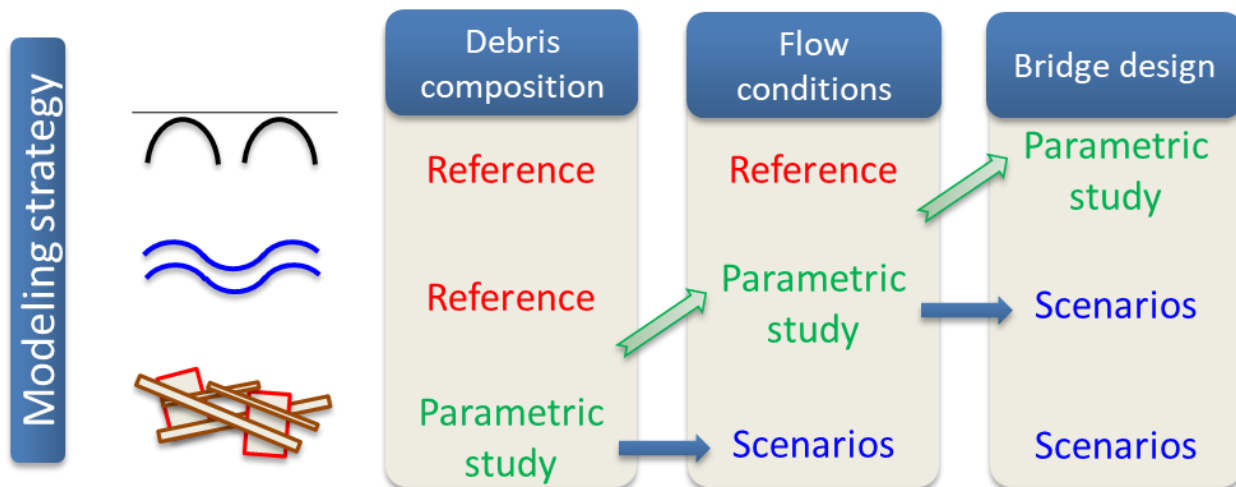
Figure 7: Modelling Strategy

The experimental modelling was divided into three phases: the variation of the debris composition, the flow conditions and the bridge design (see Figure 7). In total 285 experiments were conducted for this part of the deliverable. To maximize comparability between labs, the test setups at all three labs were as similar as possible. In all three labs, tests at 1:16 scale were performed in flumes of 1.2 m width. In Liège, tests were additionally performed at a 1:18 scale in a flume of 1 m wide. A bridge was present in each of the flumes, all with the same height for the 1.2 m wide flumes. Debris was dropped into the flume, every three minutes in small batches from a drop-in device, to measure how backwater rise increases with debris volume. Any debris that passed the bridge was immediately re-added with the drop-in device, to ensure the accumulation volume at the bridge equals the known dropped-in volume. For the debris composition tests, the effect of seven different debris mixtures (based on the mixtures determined in chapter 2) on clogging and backwater rise was studied, under fixed hydraulic conditions and bridge design (see chapter 3.1.2). For the second experimental phase on flow conditions, the initial water depth and the Froude number were varied. For the analysis of the bridge design, the opening shape, the number of piers and the handrail design were varied. During these tests, the water levels were recorded by ultrasonic water level sensors upstream and downstream of the bridge. The test setups in all three labs, debris mixture and test program are described in more detail below.

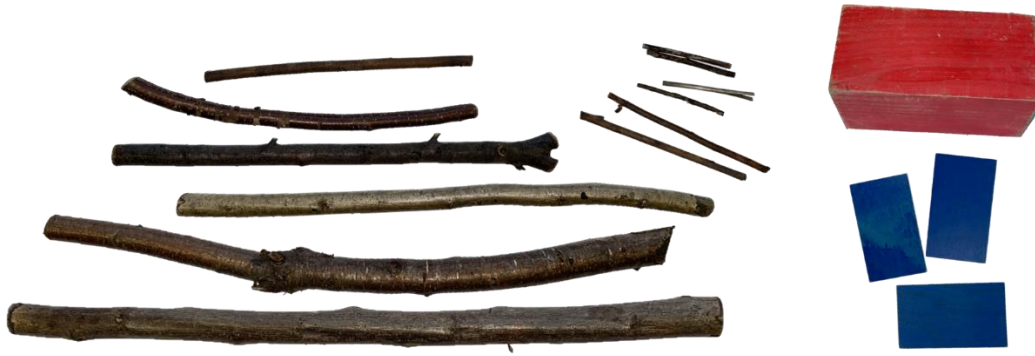
Figure 13: Debris components

Three types of debris were considered in this study: logs, cubes and plates. Logs were represented by sticks with a length of 10 cm up to 80 cm. Flat objects such as building rubble or panels from destroyed caravans were imitated by blue plywood plates with a thickness of 2 mm, a height of 60 mm and a length of 100 mm. Voluminous objects like cars and tanks were represented by red wooden cubes from Douglas fir with the size 9 × 9 × 18 cm. Based on debris compositions of accumulations during the 2021 flood event (chapter 2), seven different debris mixtures were created, shown in Table 2. In Appendix 2, the detailed compositions with the corresponding number of logs, plates and cubes for each debris composition is listed. Furthermore, weight and density measurements for the debris components in wet and dry stage can be found in Appendix 3.

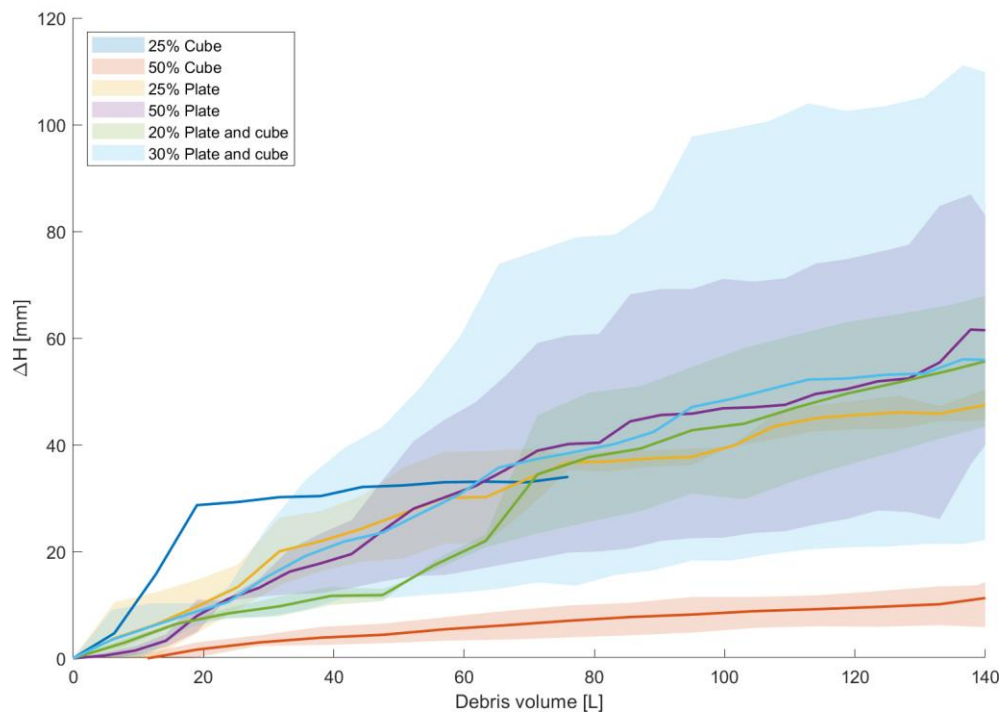
Figure 16: Backwater rise for the tests conducted with varying debris compositions in Aachen

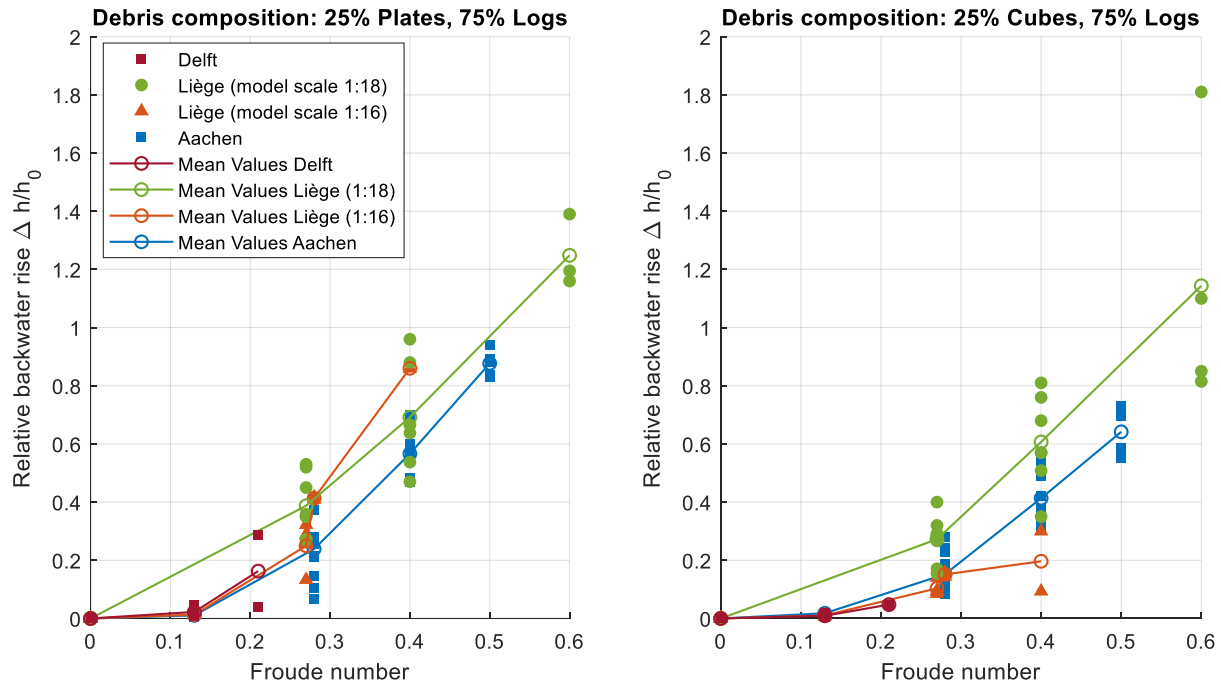
Figure 17: Relative backwater rise for the experiments conducted with a debris composition of 25% plates and 75% logs and 25% cubes and 75% logs for varying Froude numbers

Between all three laboratories, a similar relation between the backwater rise und Froude number could be observed (slope of the lines in Figure 17). By exchanging the bridges between Aachen and Liège, it could

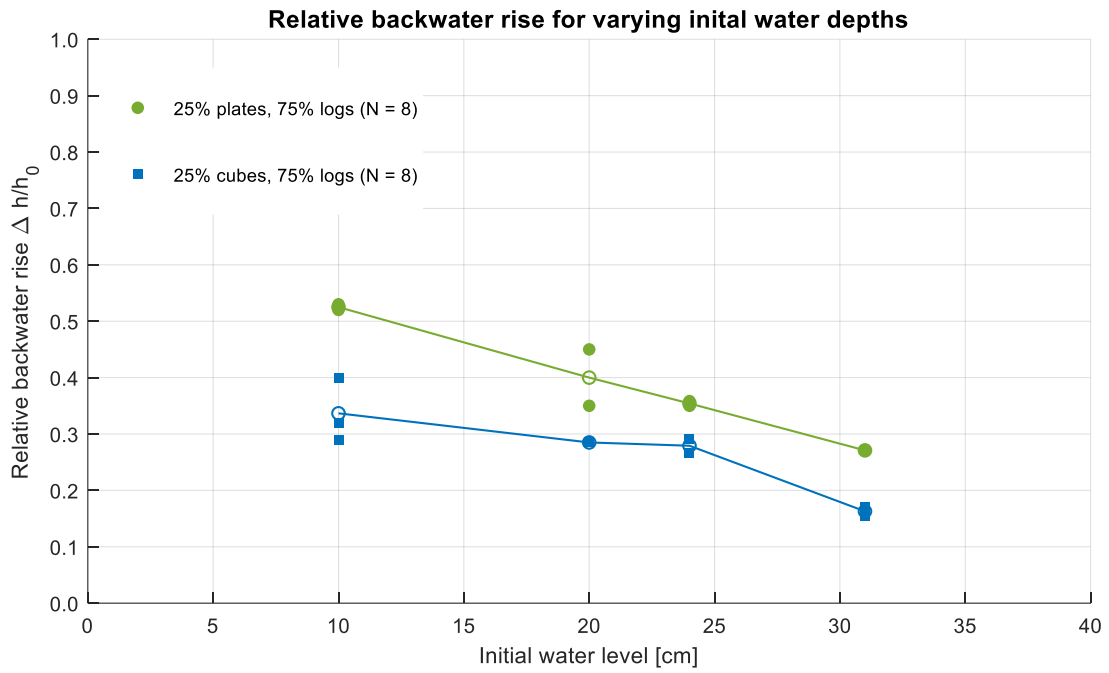
Figure 18: Relative Backwater rise in relation to the initial water depth h_0 for the model in Liège with a scale of 1:18

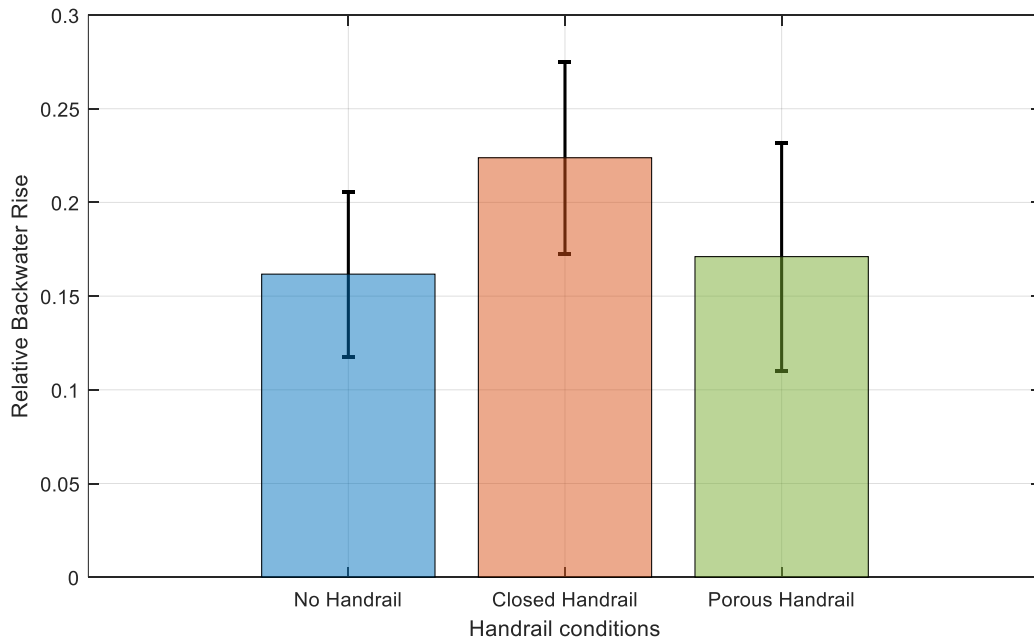
Figure 19: Relative backwater rise for different handrail designs for the tests conducted in the lab in Aachen

During the tests with different **handrails**, tests in Aachen showed that having a closed handrail (wall) increases the backwater rise by debris, compared to a porous handrail or no handrail (Figure 19). Similar tests in Delft, with the water level near (what would be) the top of the handrail, first showed that without handrail no debris is blocked, as all debris flows over the bridge. Secondly, having no handrail decreases the backwater rise caused by the bridge itself. A porous handrail adds some backwater rise and a closed handrail adds clearly more backwater rise by blocking the flow, while streamlining the bridge by rounding the deck decreases backwater rise (Figure 20, blue bars). Regarding backwater rise by debris (Figure 19, orange bar), backwater rise by the closed handrail is clearly larger, similarly to Aachen. In practice, having no handrail would not be safe, so this bridge design can be regarded as either a handrail that is already destroyed by floating debris, or as a handrail that can collapse when the bridge is flooded.

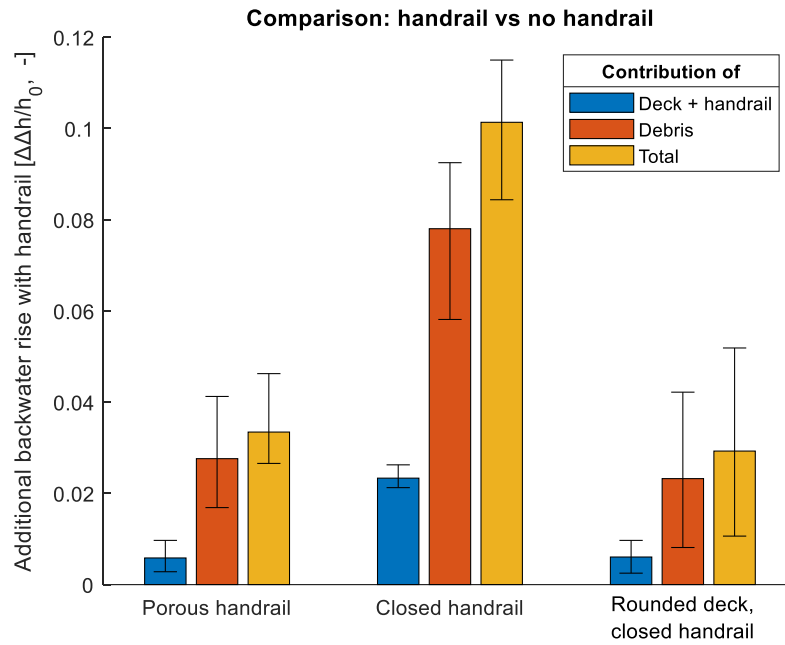
Figure 20: Relative backwater rise for different handrail designs, compared to a bridge without handrail. Data Delft, $Fr_0=0.15$, h_0 near the top of the handrail. NB: this figure also plots backwater rise by the bridge itself, in all other plots backwater rise purely refers to backwater rise from debris.

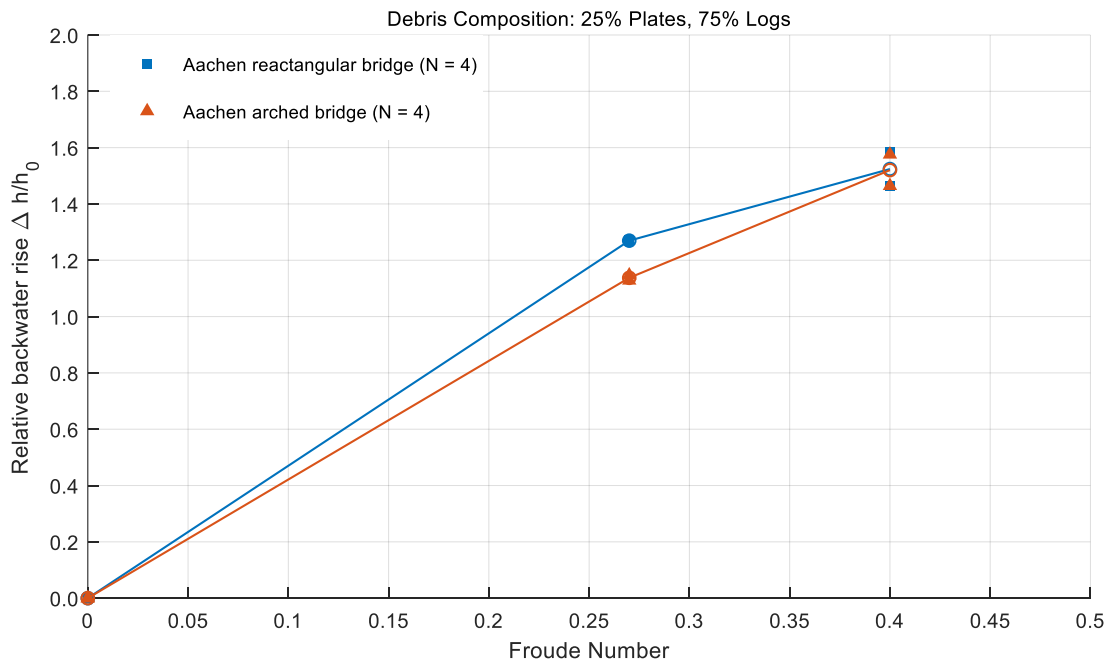
Figure 21: Relative backwater rise for bridges with rectangular and arched opening shape in the flume in Aachen

be observed, that the shape of the bridge opening shows only minor variations in the backwater rise (see Figure 21). The effect on the backwater rise further decreases with increasing Froude number. Furthermore, it could be observed, that the probability of clogging decreased as soon as the Froude number increased. Regarding tests with different **pier** configurations, it could be seen, that the probability of clogging reduced strongly when decreasing the number of piers.
